## Service Info

# Tensioner pulleys 531 0264 10 and 531 0780 10

**Before installation, be sure to check the sleeve screw on the engine side**

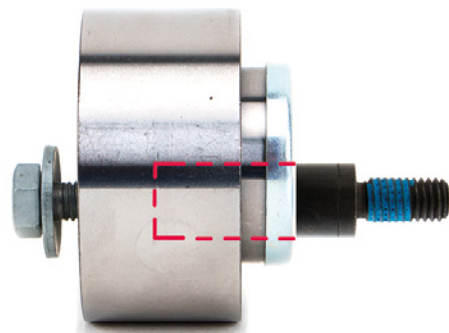
Fig. 4: Tensioner pulley with sleeve and fixing screw in the installed position

When the tensioner pulley is removed from the vehicles listed here, it is absolutely essential to ensure that the sleeve screw (Fig. 1) on the engine side is securely installed.

If the sleeve screw is loose, it must be re-tightened with the appropriate tool to the specified tightening torque.

Failure to do so can result in toothed belt damage. In the worst case, this can in turn cause engine failure.
